# **Teardown Evaluation of Areas of Interest From the T-34A N141SW Aircraft Wreckage**

March 2006

DOT/FAA/AR-TN05/57

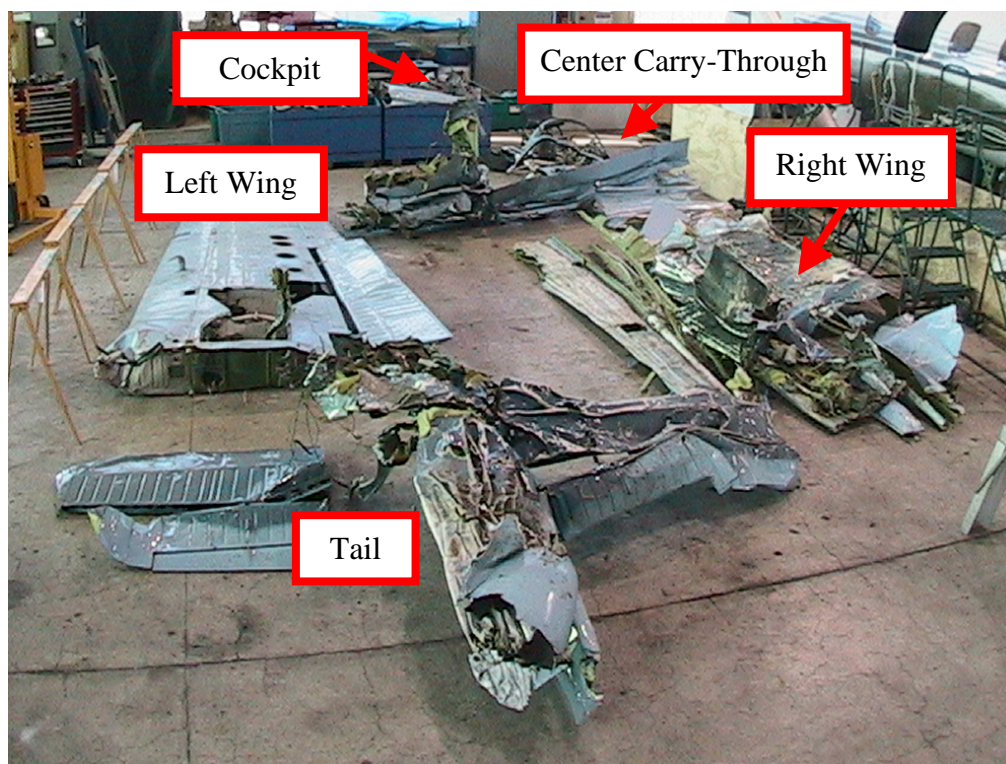
FIGURE 2. WRECKAGE AS RECEIVED

Figure 2 shows the wreckage as it was received prior to disassembly. All sections of the aircraft were received, except for several areas on the left wing that were previously removed by the NTSB for examination.

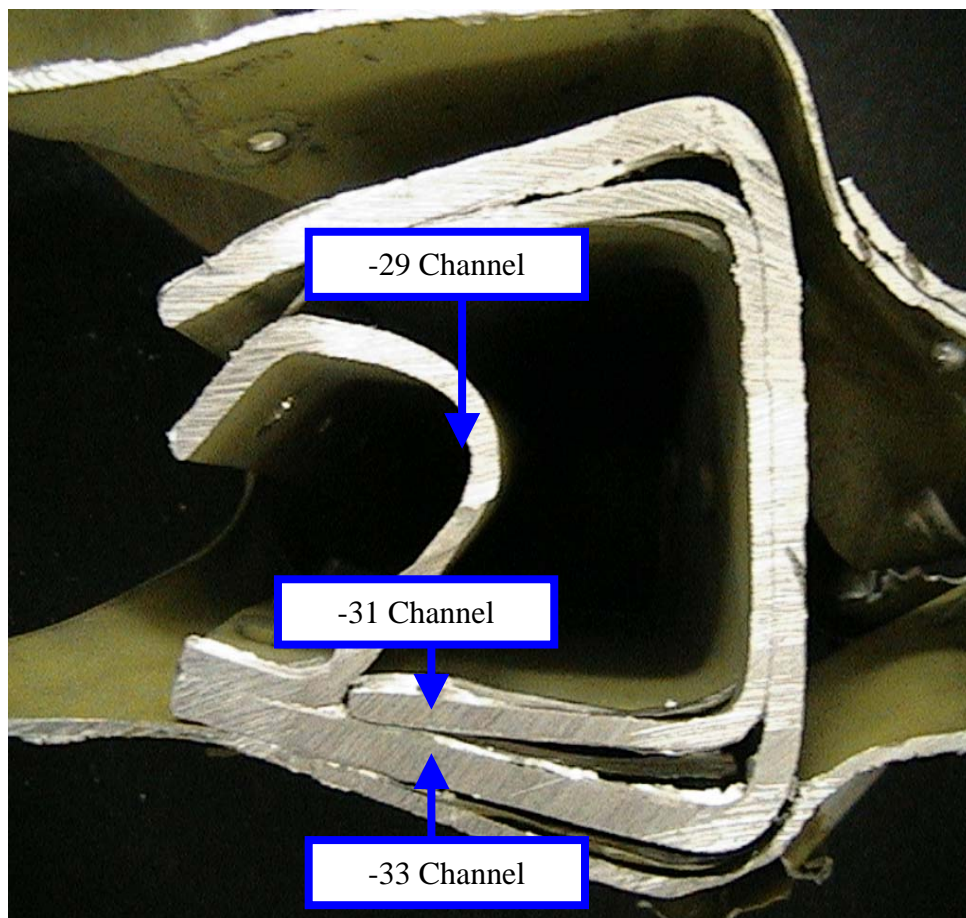
FIGURE 8. RIGHT WING FRONT CARRY-THROUGH STACKUP

Twenty-five cracks were found on the right wing front carry-through, which is composed of three channels and web skins, as shown in figure 8.

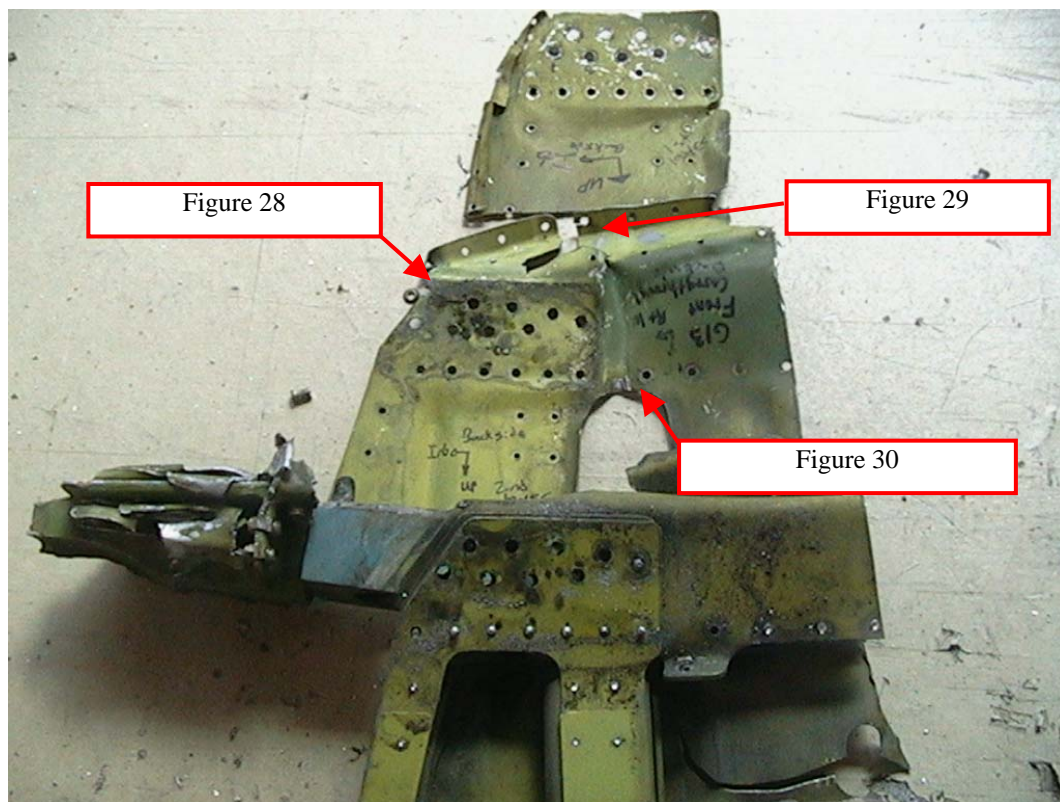
FIGURE 27. RIGHT WING FRONT CARRY-THROUGH AFT SIDE STACKUP

Figure 27 shows the right wing front carry-through aft side structural stackup. The locations of cracks 13-15 are shown in figure 28. Crack 13 had a total length of 0.31 inch with an initial fatigue length of 0.05 inch, which was through the thickness, as shown in figure 29. Figure 29 also shows the location of the origin of this crack. Crack 14 had a total length of 0.52 inch, with an initial fatigue length of 0.22 inch. This crack was also completely through the thickness. The fracture face for crack 14 is provided in figure 30 and shows the location of the origin along with the existence of a transition period of rapid growth, which was comprised of unstable fatigue that extended the crack length 0.05 to 0.10 inch prior to the final growth increment due to overload. Crack 15 had a total length of 0.26 inch and was not opened for examination.

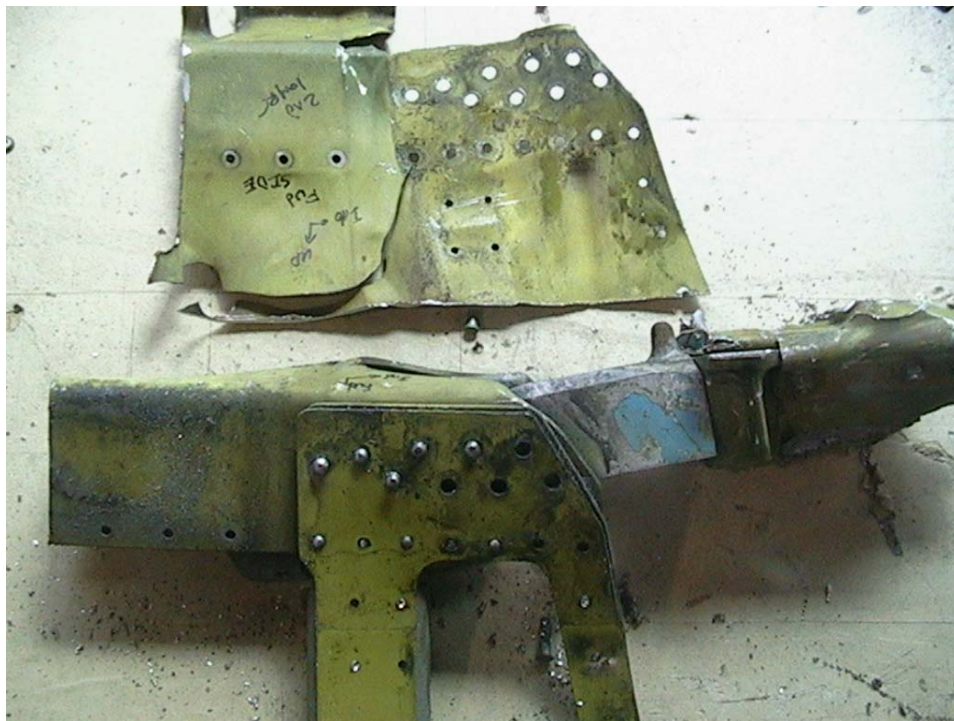
FIGURE 38. RIGHT WING FRONT CARRY-THROUGH FORWARD SIDE STACKUP

Figure 38 shows the right wing front carry-through forward side stackup. Figure 39 shows the location of crack 23, which had a total length of 5.28 inches and was caused solely by overload. Figure 40 shows the locations of cracks 24 and 25. Crack 24 had a total length of 0.99 inch with a fatigue length of 0.79 inch. This crack had fatigue origins from the forward side of the web skin. The fracture face for crack 24 is shown in figure 41. Crack 25 had a total length of 0.21 inch, with an initial fatigue length of 0.18 inch. This crack had similar origination points as crack 24, and both cracks were though the thickness at some points but not for the entire length of the crack. The faces of cracks 24 and 25 were severely damaged from rubbing against each other, which makes it difficult to identify individual origins and crack shapes. It is possible that the hole between the cracks is actually a stop-drilled hole, which is an effort to prevent further fatigue crack growth. This idea has not been proven and is only supposition at this point.
